MODIFICATION AND LABORATORY EVALUATION OF A SHIPBOARD  
MULTIFUNCTIONAL WAS... (U) NAVAL SURFACE WEAPONS CENTER  
DAHLGREN VA J A BYRNE ET AL. MAY 82 NSWC/TR-82-71

4. TITLE (and Subtitle) MODIFICATION AND LABORATORY EVALUATION OF A SHIPBOARD MULTIFUNCTIONAL WASTE INCINERATOR (MFI), PHASE II		5. TYPE OF REPORT & PERIOD COVERED Final

7. AUTHOR(s) J. A. Byrne W. W. Jones		6. PERFORMING ORG. REPORT NUMBER
9. PERFORMING ORGANIZATION NAME AND ADDRESS Naval Surface Weapons Center (G51) Dahlgren, VA 22448		8. CONTRACT OR GRANT NUMBER(s)

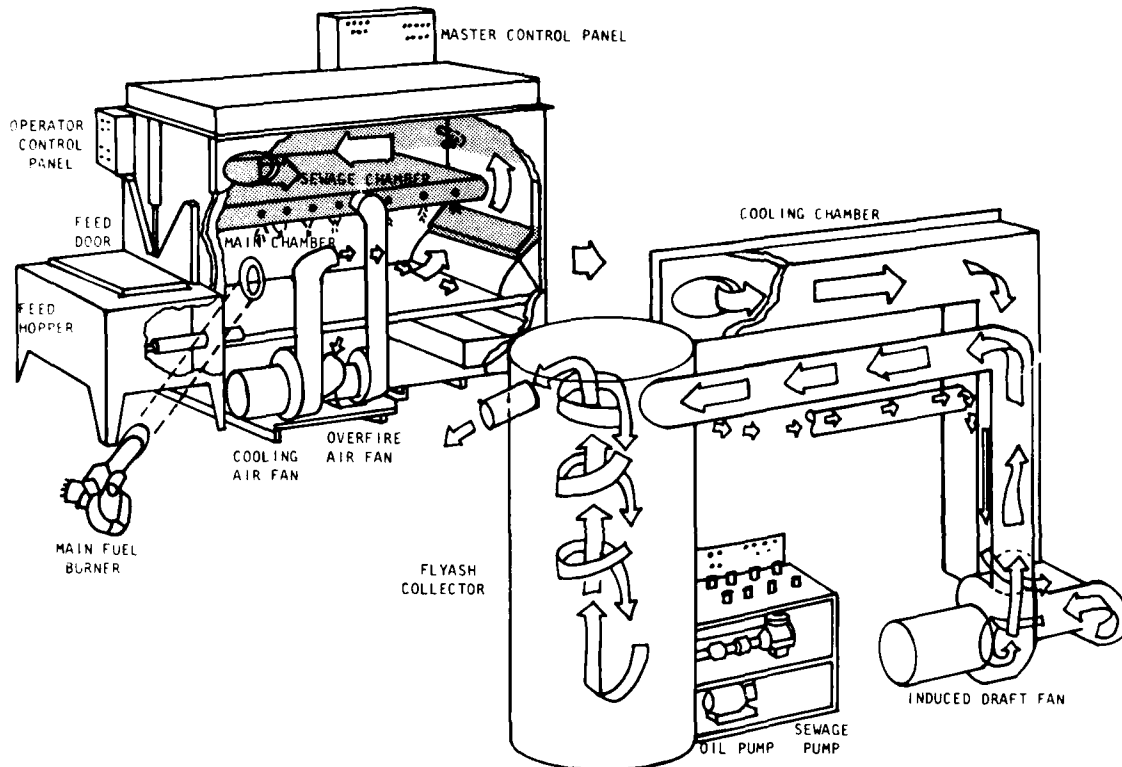
1. Deteriorated refractory material in the sewage and main chambers, as shown in Figure 2
2. Lack of refractory material in the base of the cooling chamber
3. Deterioration of cooling jacket insulation
4. Poor location of the sewage chamber cleanout/viewing port for adequate cleaning of the ashes
5. Poor air flow in the cooling jacket

Figure 2. Deteriorated Refractory Sections (Shaded Sections) of MFI Phase II

These deficiencies were dealt with by partially refurbishing the MFI from August through September 1979. This refurbishment began with the careful disassembly and evaluation of the incinerator to determine the condition of all components, especially those accessible only through disassembly.

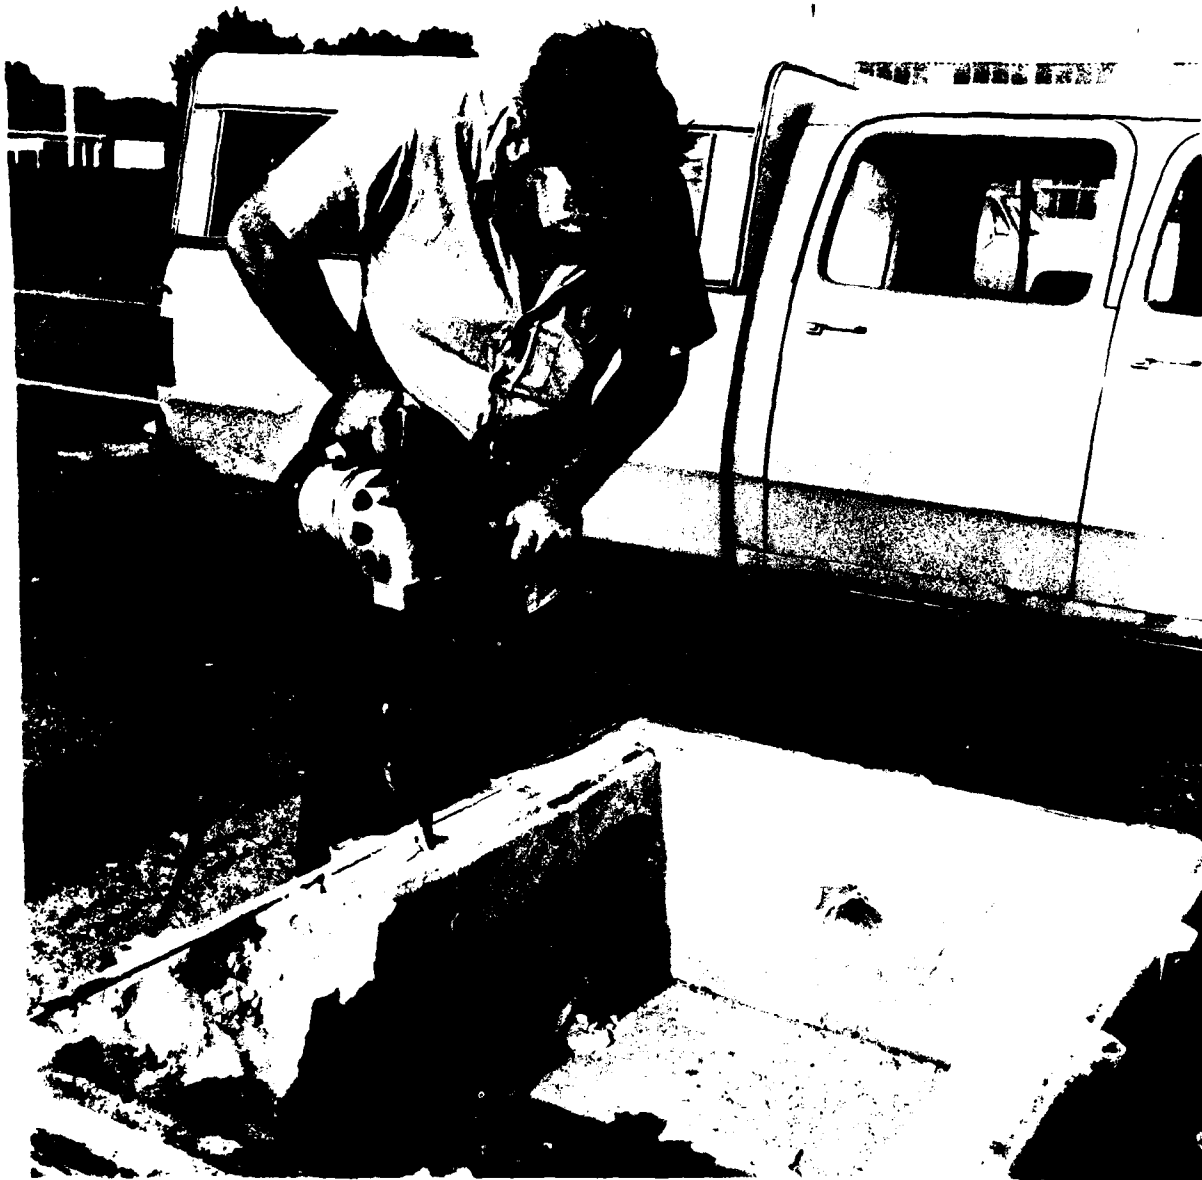
The refractory material of the sewage chamber, partition, and ash door overhead was removed as shown in Figures 10 and 11. The condition of the metal structures is shown in Figures 12, 13, and 14. Figure 12 shows the sewage roof metal structure. Figure 13 is a front view of the sewage chamber wall metal structure. The partition's metal structure, shown in Figure 14, was repaired by replacing the destroyed air manifold pipe. The location of that pipe was also changed, so that an increased thickness of refractory material protected the pipe. All metal structures were then sandblasted and

Figure 11. Refractory Removal from the Sewage Chamber

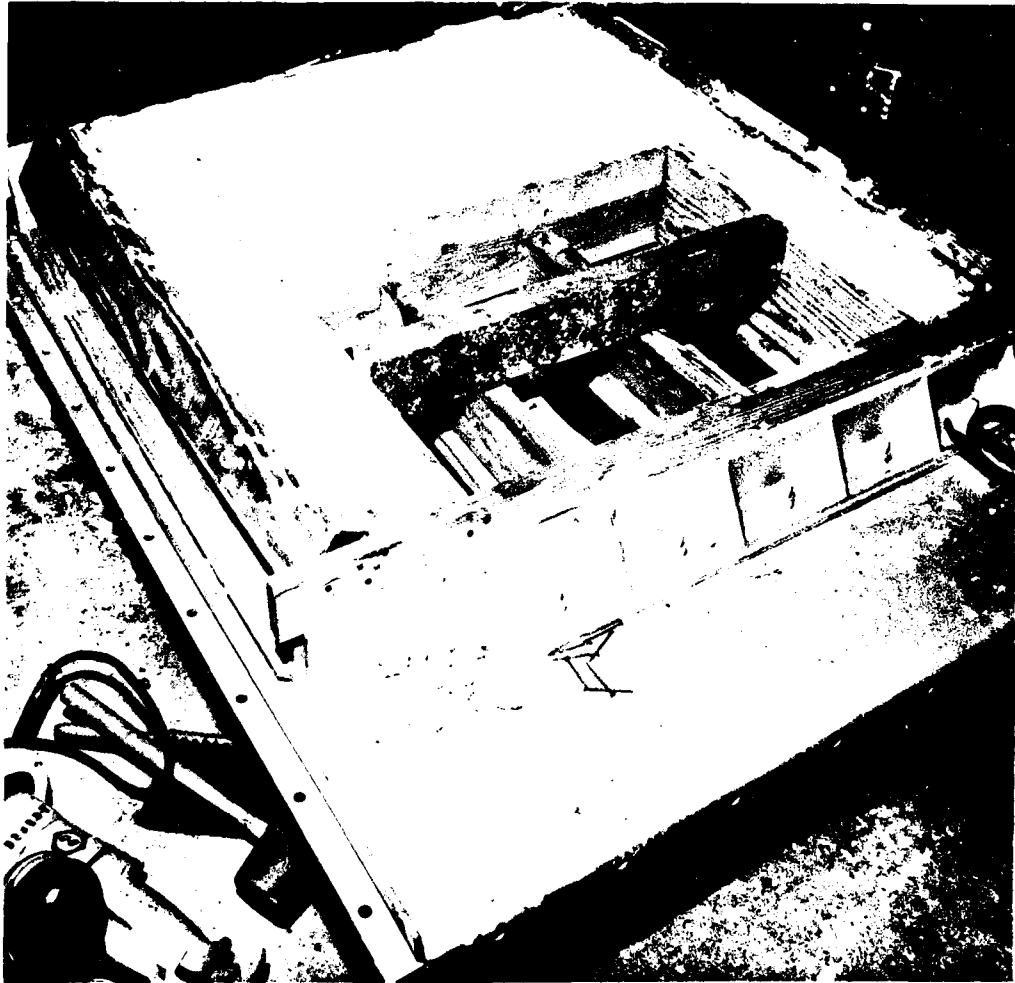
The front wall of the incinerator was refurbished with a castable insulating refractory, KAST-O-LITE 30®, because there were extensive cracks in the wall. The finished wall is shown in Figure 19. Note the V-shaped expansion etches, which were supposed to relieve expansion/contraction stresses. Such stresses can cause large cracks in the refractory.

Figure 19. The Front Wall After Casting with the Form in Place

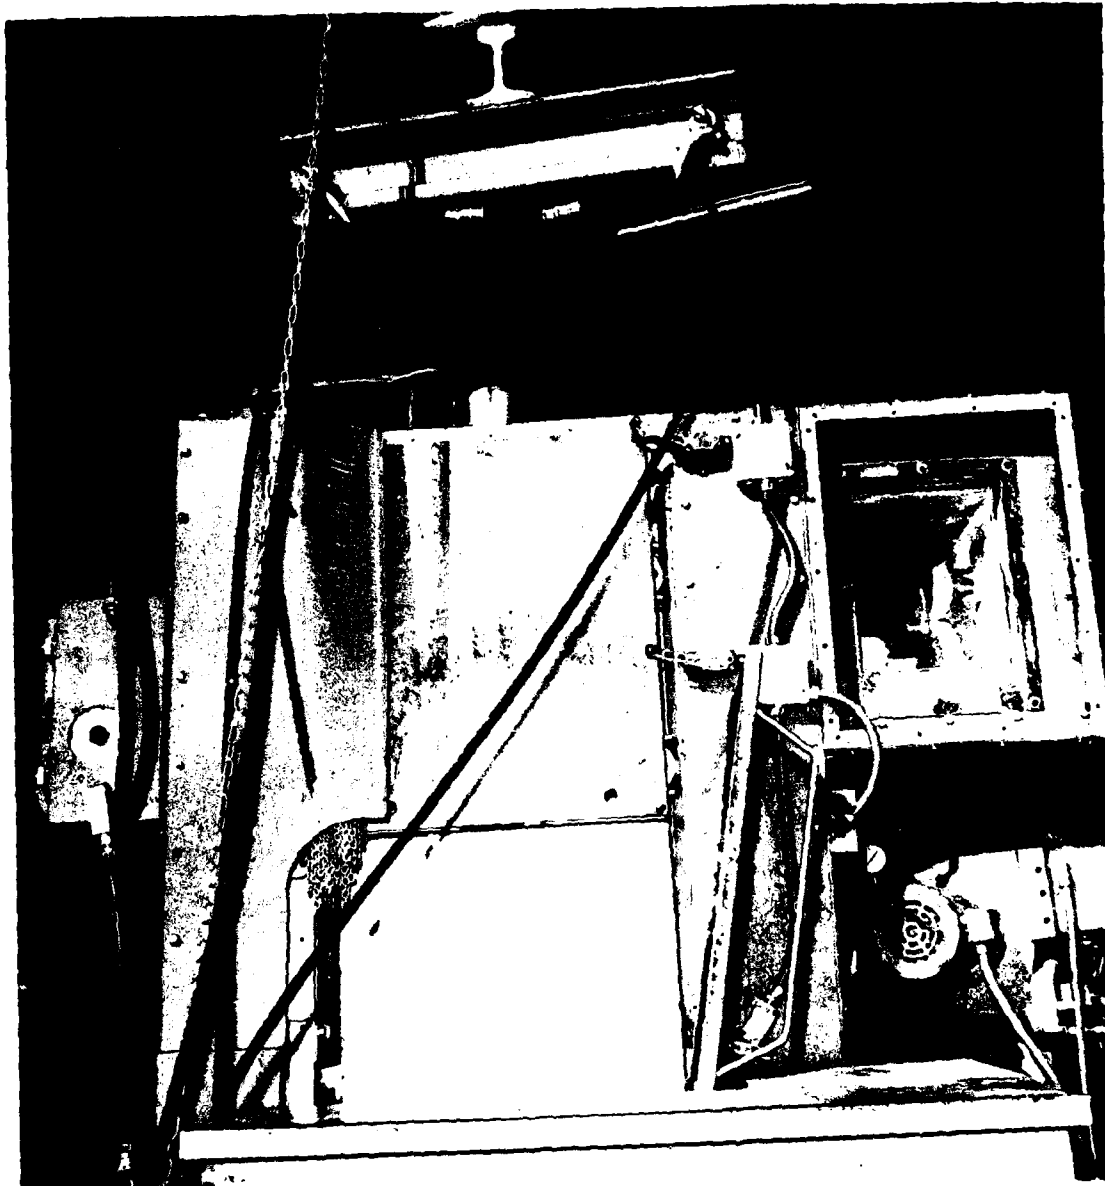
Figure 47. The Cooling Chamber and Chain Curtain Guard Damage

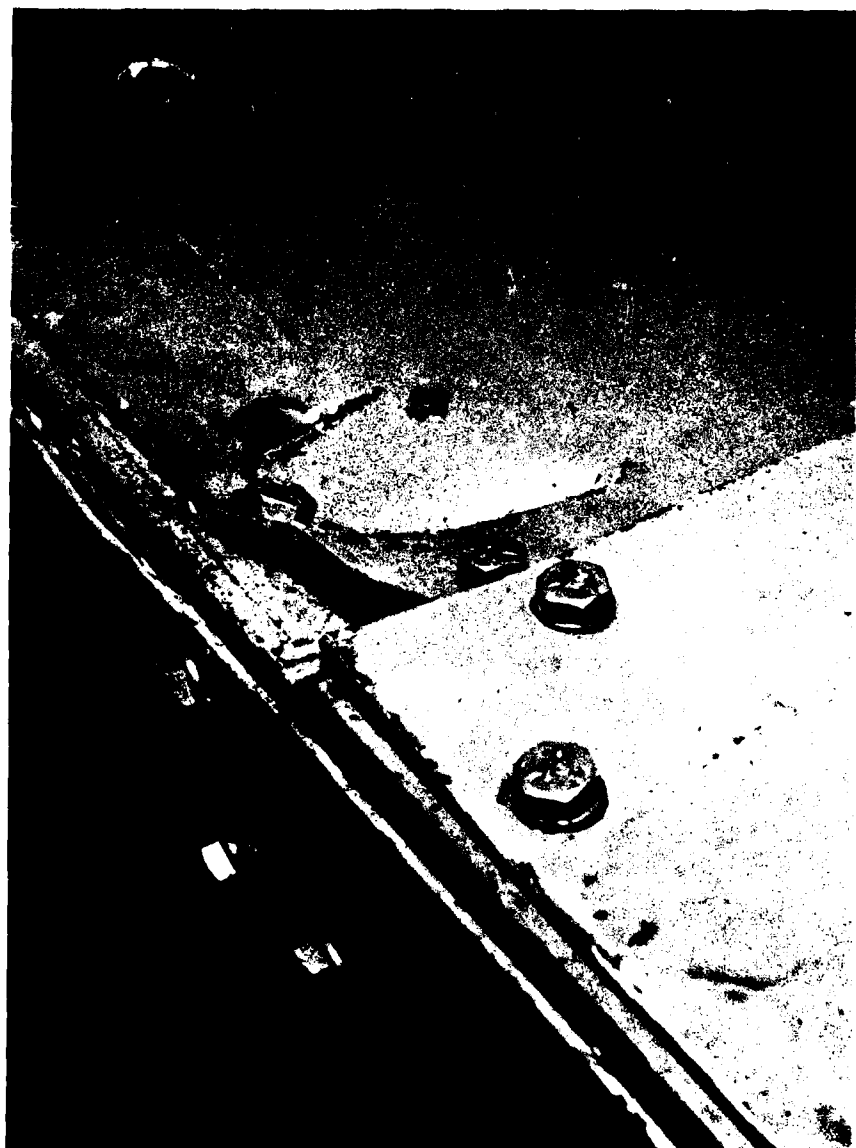
Figure 51. Damaged Cooling Jacket Roof Panel
